# Navajo Abandoned Uranium Mine

# Site Screen Report

Mine Name: Mitten No. 3

Mine ID: 260

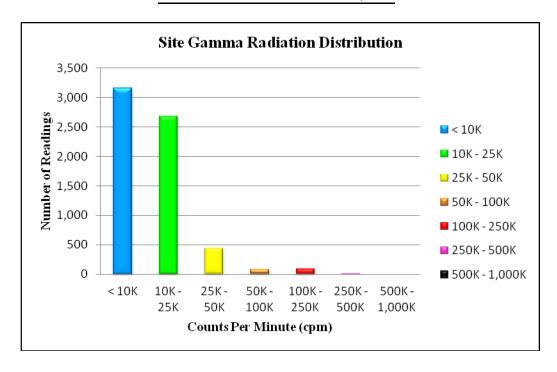
#### **Distribution Chart and Statistics:**

<b>Site Gamma Radiation</b>	Statistics
Number of Readings	6,824
Minimum (cpm)	4,003
Maximum (cpm)	328,340
Mean (cpm)	13,894
Median (cpm)	9,324
Standard Deviation	17,407

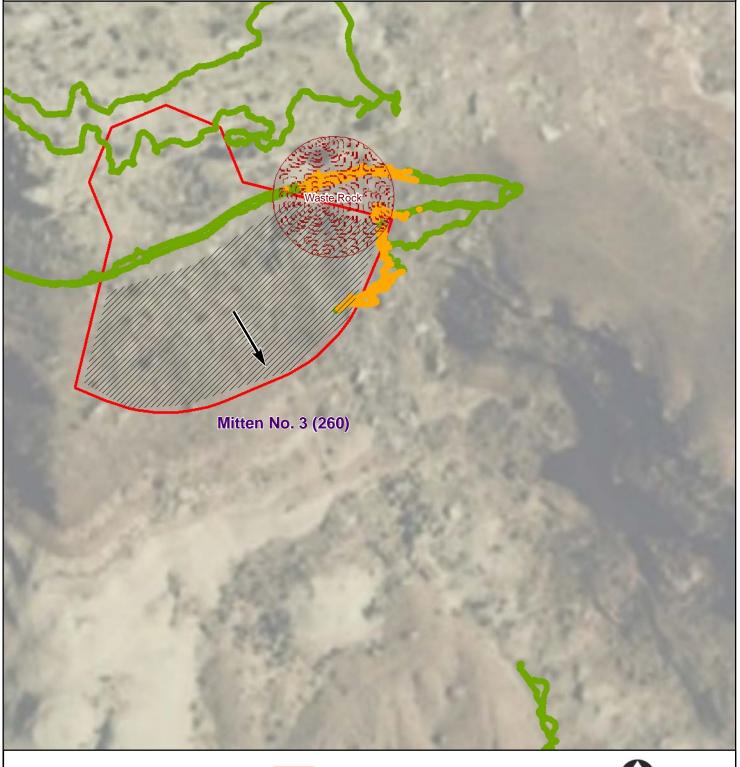
## **Gamma Radiation Measurements**

A total of 6,824 gamma radiation measurements were collected from the mine site, ranging from 4,003 cpm to 328,340 cpm. Maximum levels of approximately 330,000 cpm were found in the vicinity of the waste rock. The measurements are represented in Figures 1 and 2.
